# WELDING INSPECTION REPORT

Resident Engineer: Siegenthaler, Peter **Report No:** WIR-018474 Address: 333 Burma Road **Date Inspected:** 22-Nov-2010

**OSM Arrival Time:** 700 **Project Name:** SAS Superstructure **OSM Departure Time:** 1330 **Prime Contractor:** American Bridge/Fluor Enterprises, a JV

**Bridge No:** 34-0006 **Component: Travelers**

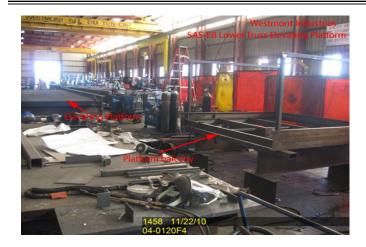
The QA Inspector observed WMI production personnel Mr. Raymundo Anaya (WID # 3196) and Mr. Cesar Canales performing fitting and Flux Core Arc welding (FCAW) activities on the Elevating Platform, for the Lower Truss Section. The QA Inspector observed that the fitting and tacking activities were being performed on the Stair Risers, piece marks identified as C270F, to Stair Supports, piece marks identified as A270F and B270F. The QA Inspector observed that the fitting and tacking activities were also being performed on what appeared to be various plate material fillet and flare groove welds. In addition, the QA Inspector observed Mr. Anaya and Mr. Canales performing fitting and tacking activities on the Platform Balcony Assembly, for the Lower Truss Section. The QA Inspector observed the activities being performed on channel and Tube Steel (TS) material. The QA Inspector then referenced the nearby shop drawings and the Platform Balcony appears to connect to the Elevating Platform Assembly.

See attached pictures below.
